SUBJECT: Five-Year Review for the City of Coalinga OU of the Atlas and Coalinga Superfund Sites, Coalinga, CA

**CITY OF COALINGA OPERABLE UNIT
FIVE-YEAR REVIEW**

Coalinga, California
Fresno County

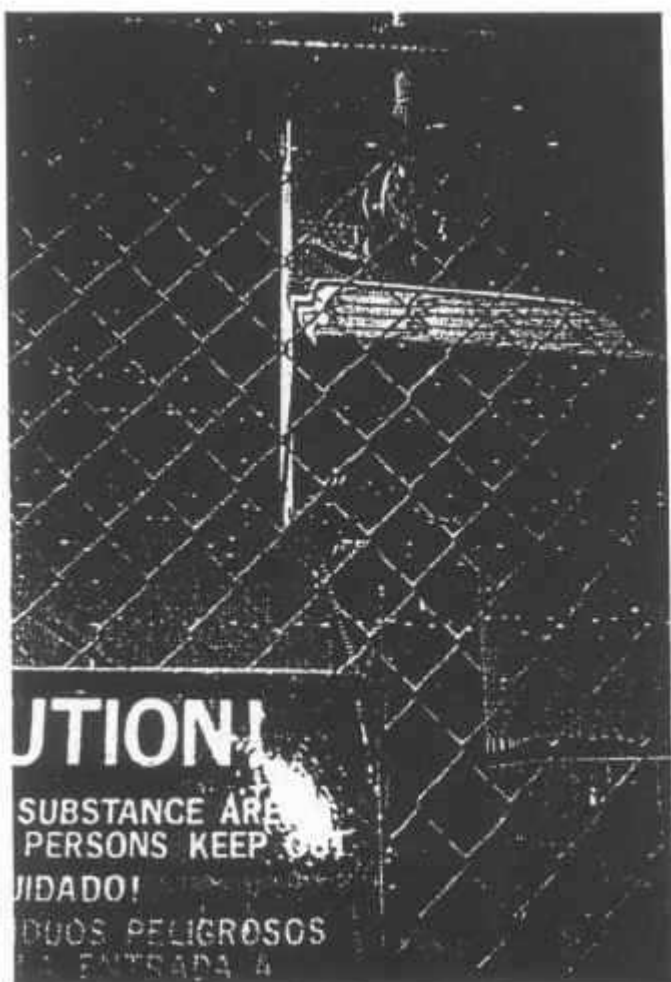
Description: Closeup of electrical service meter at Waste Management Unit. Note: the meter is too high up to determine if it is operational.

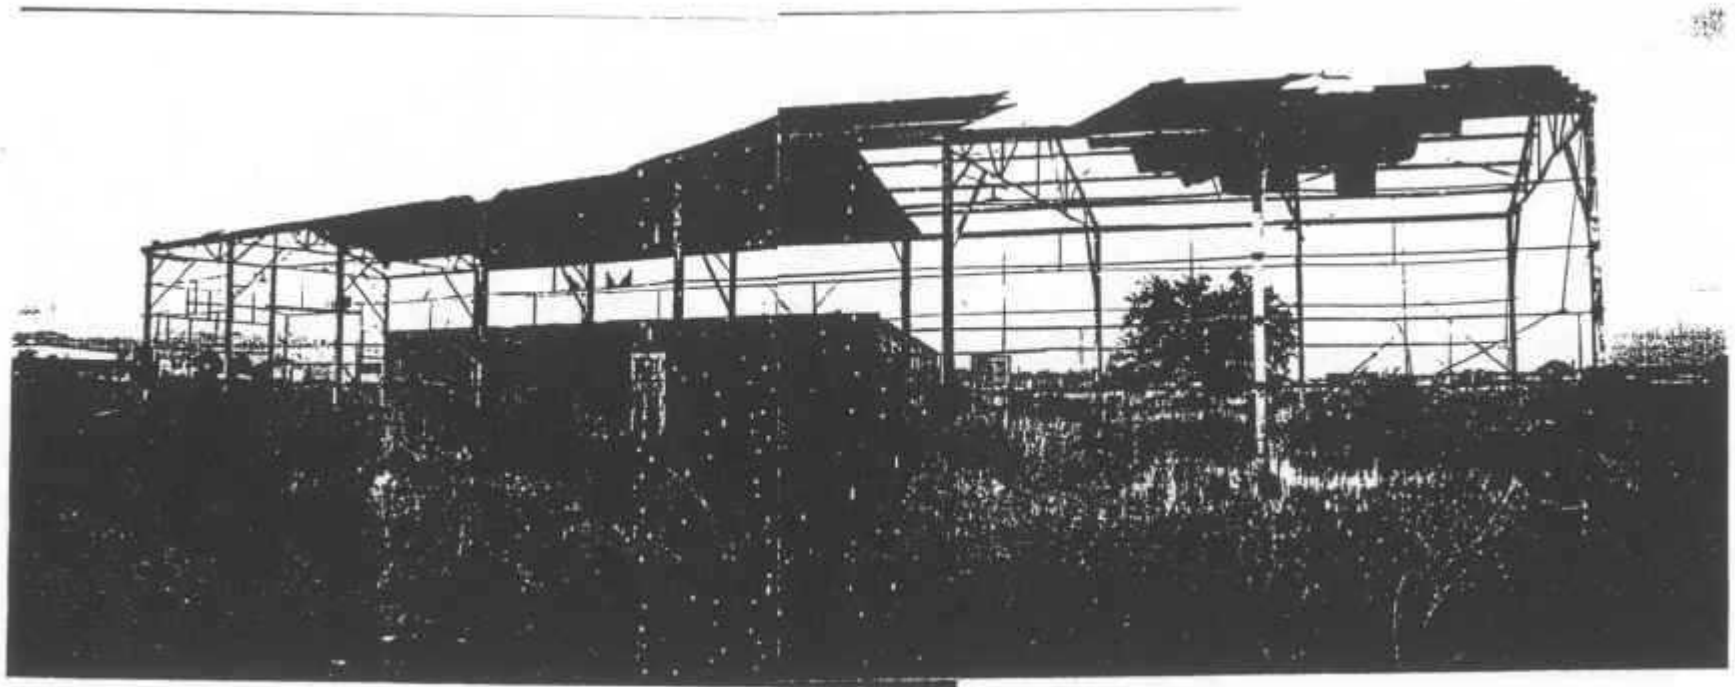
Inspection of the Echo Transport Building revealed that it has been partially dismantled since completion of the remedial action. During decontamination of the Echo Transport Building, suspected asbestos ore waste was noticed between the overlaps of the corrugated metal siding panels. According to the Remedial Action Report, suspect areas were most prominent in the panels from the ground to the 4-foot level so they were removed from this level from the north and south sides of the building. The remaining panels and the building superstructure were steam cleaned then sprayed with an encapsulant to complete their decontamination. During the recent inspection, however, the corrugated metal siding was missing. It is unknown how the siding disappeared, but it is presumed to have been removed

Description: View of Echo Transport Building.

In its current condition, the Echo Transport Building is of concern as an attractive nuisance and it is considered a visual eyesore that may inhibit redevelopment in the area. Corrugated metal siding panels on the building have been removed, presumably by scavengers, and it is unknown if removal of the panels has disturbed asbestos that may have been present. It is also unknown if weathering or other factors have caused the encapsulant that was sprayed on the warehouse to lose its effectiveness. Sampling should be conducted at the Echo Transport Building to determine if asbestos is present at levels significantly above background. E & E recommends that final removal of the Echo Transport Building also be performed to eliminate its potential hazard as an attraction to scavengers and vandals.
